Vidago Palace Golf Course

VMPS/UNICER – Vidago - Portugal

Redesign and specific constraints

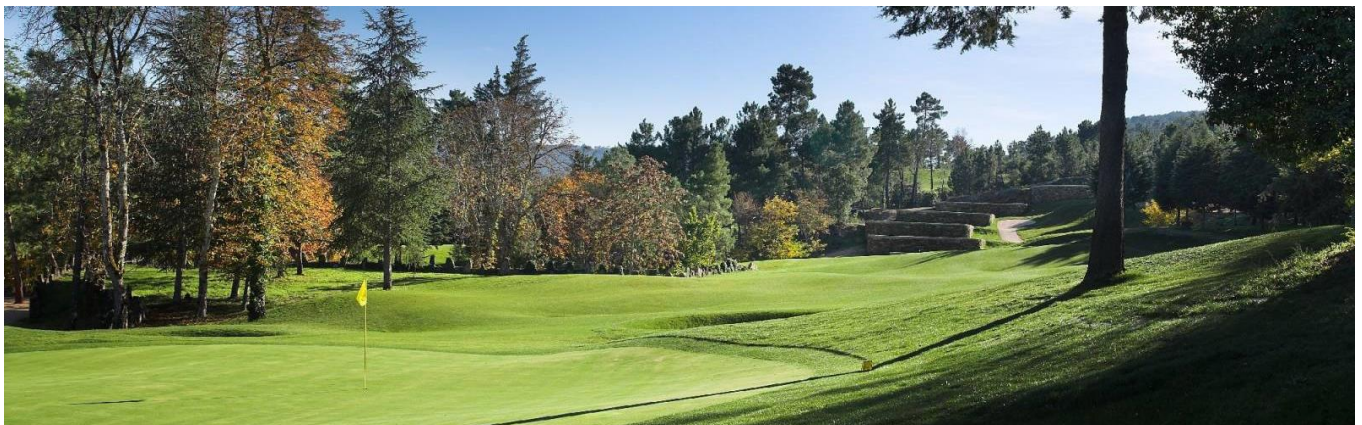
Irrigation design. During the dry months, from May to October, irrigation is fundamental and, if badly managed is also the main cause for leaching chemicals into the aquifer. As this is the main growing season the risk is real. So the irrigation system was specifically designed from the start to allow for an advanced irrigation management system, capable of minimizing irrigation volumes and leaching.

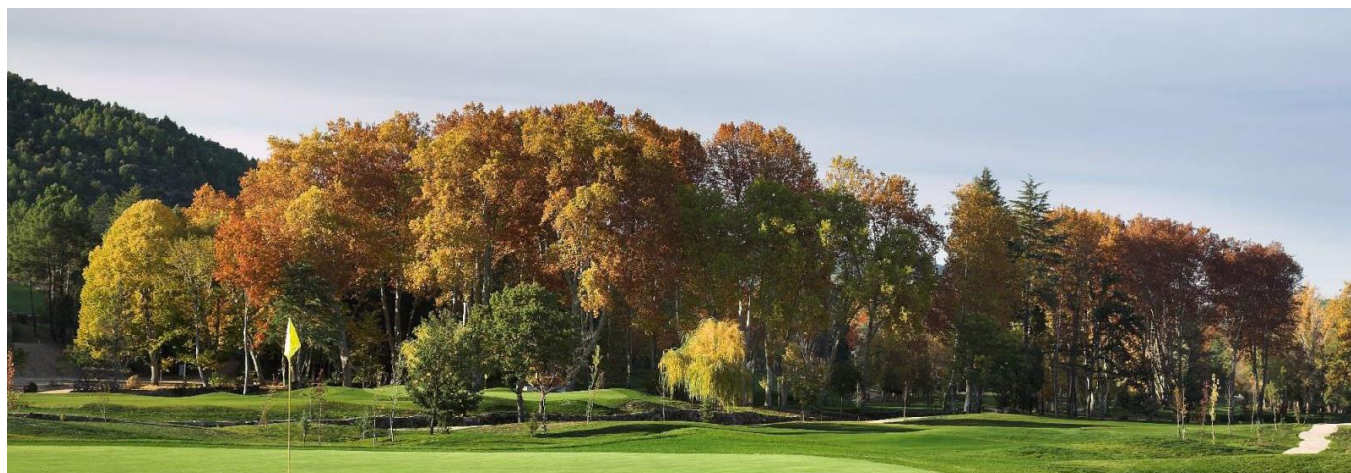
Maintenance. The fertilization and pesticides internal policy was defined specifically to minimize possible impacts. Products were selected to be mainly organic, with slow or controlled release. Whenever possible they are foliar, to limit their presence in the soil. Frequency of application is relatively high, with low quantities used, in order to limit the total amounts present in the soil at any given moment. All fertilization planning is based on frequent soil analysis. Turf is always kept at a light hydric stress. This results in a lower growth rate and mowing frequency, reducing maintenance requirements without affecting the course capability to recover from injuries due to normal play. A lower growth rate also requires less fertilizer. Pesticide use is based on the disease prediction software and threat levels analysis. Pesticides are selected for short half lives, allowing a rapid decay. All substances directly applied to the soil have limited mobility.
